### 3 ) Issues in Tsurumi River basin

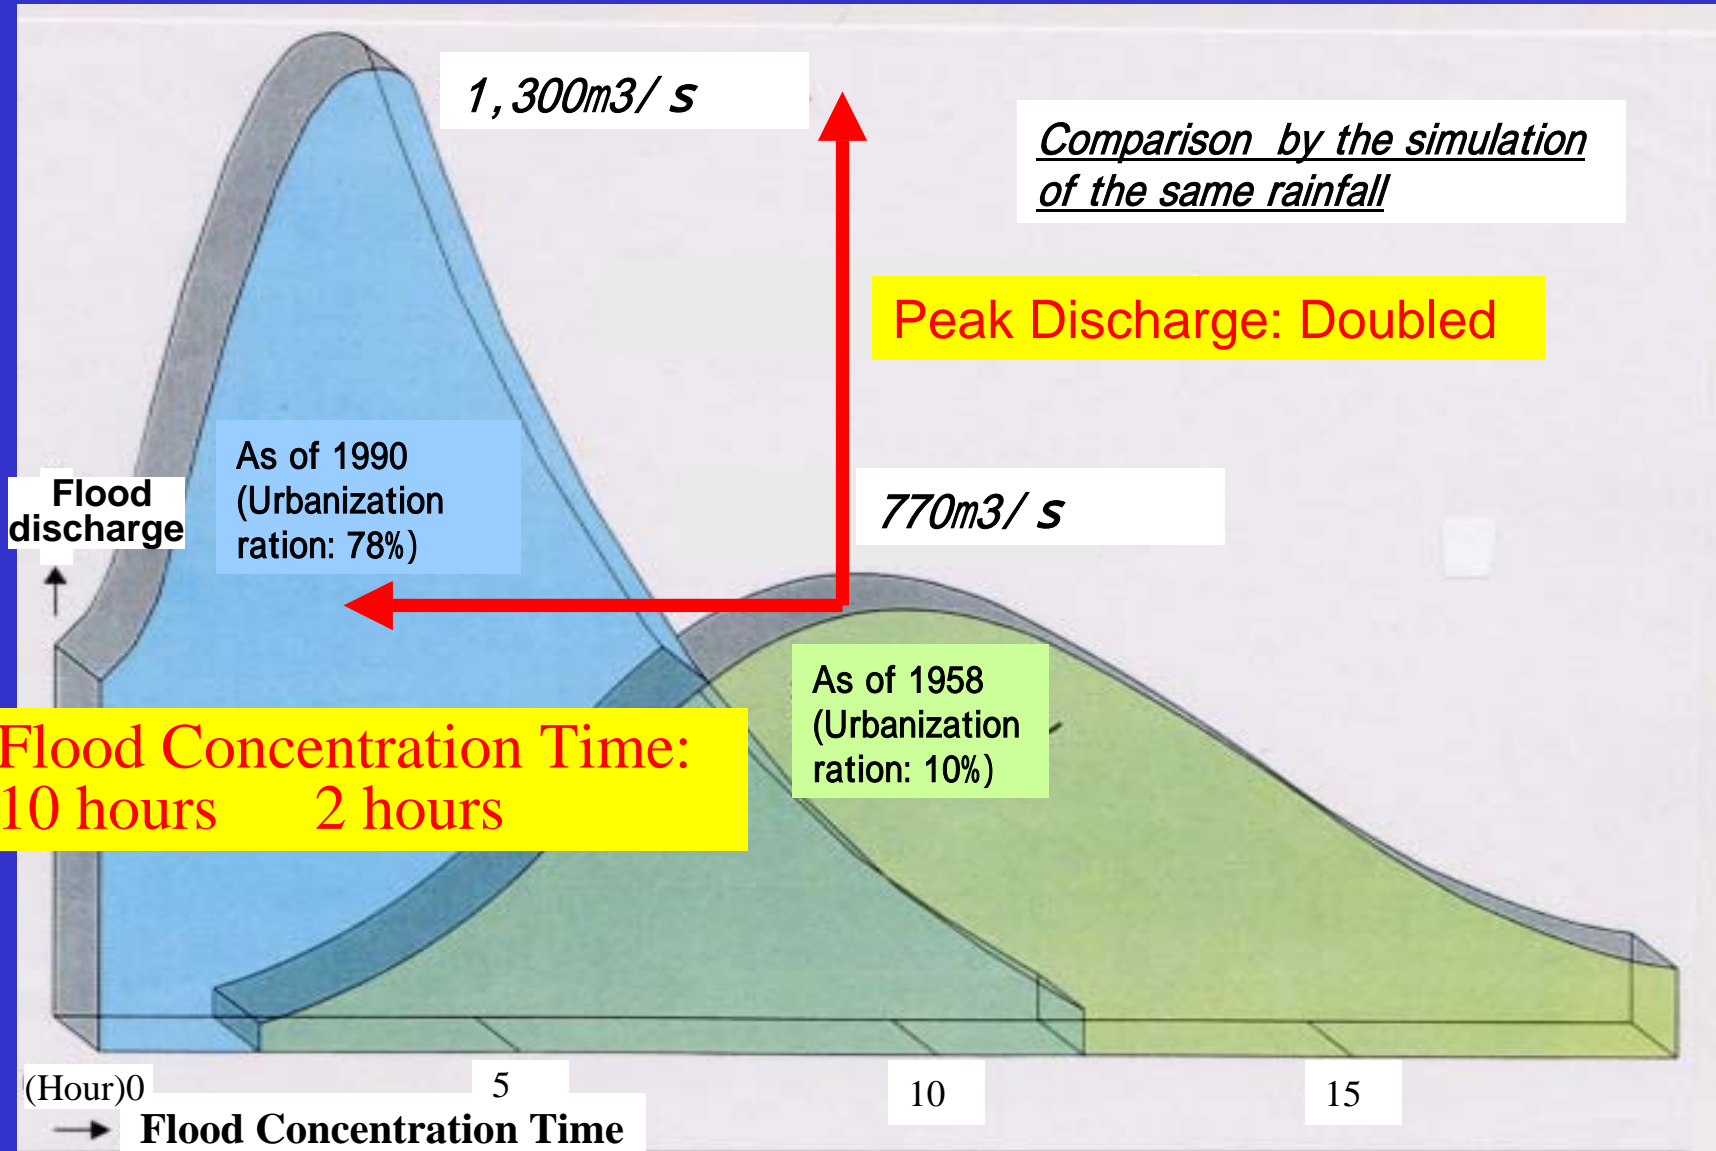
➤ Doubled peak discharge and Greatly reduced flood concentration time

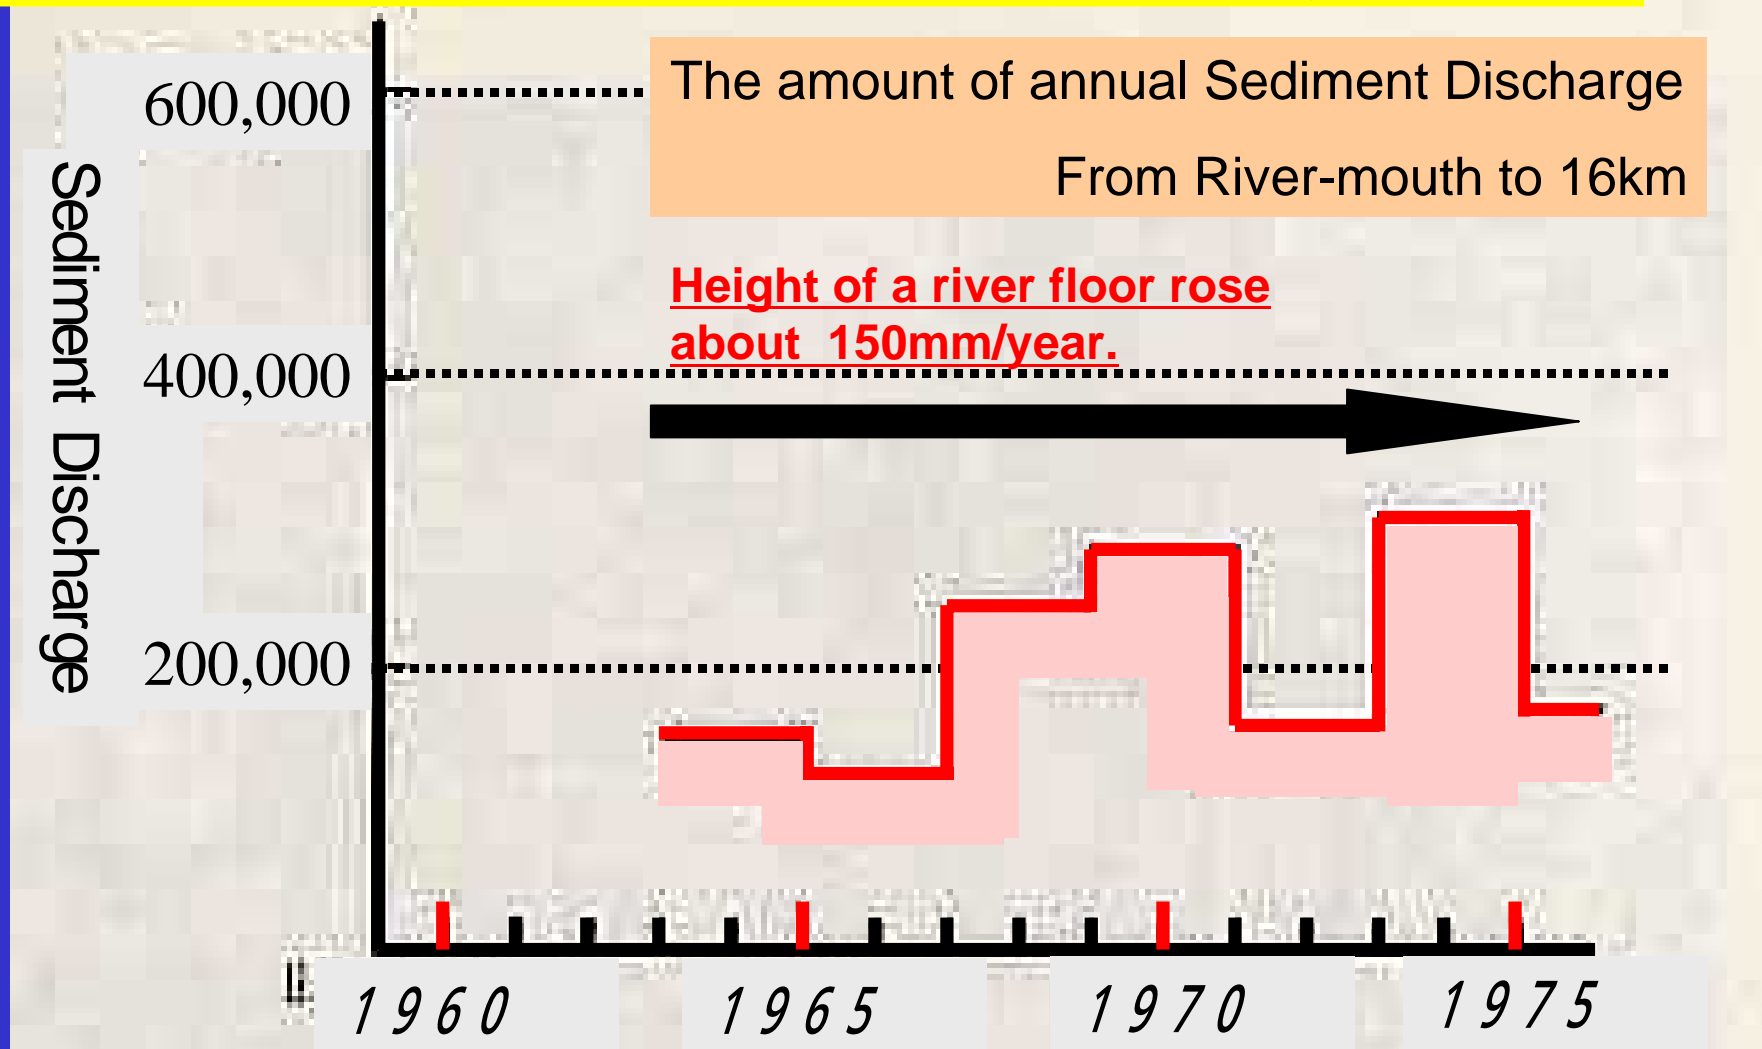
- Accumulation of the discharged sediment due to the development decreased the river channel discharge capacity

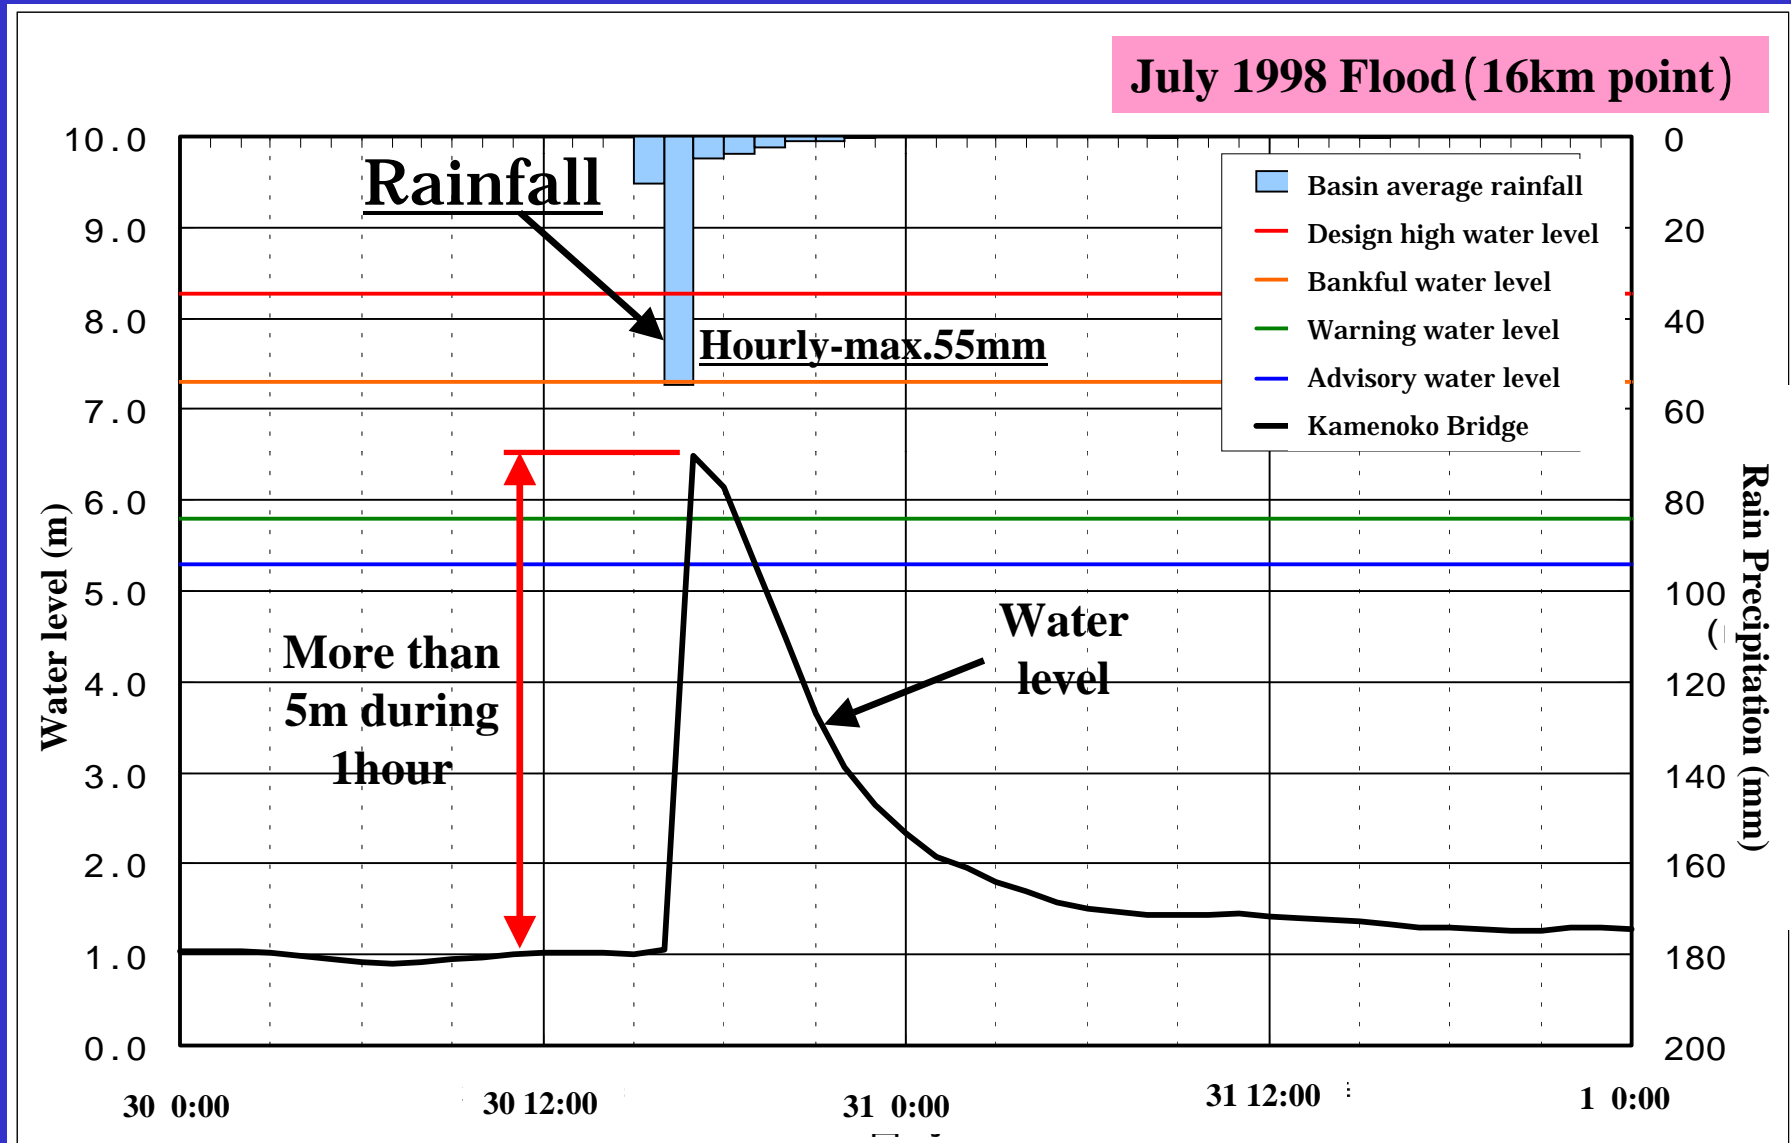
## ➤ Increased anxiety of the Torrential Rain

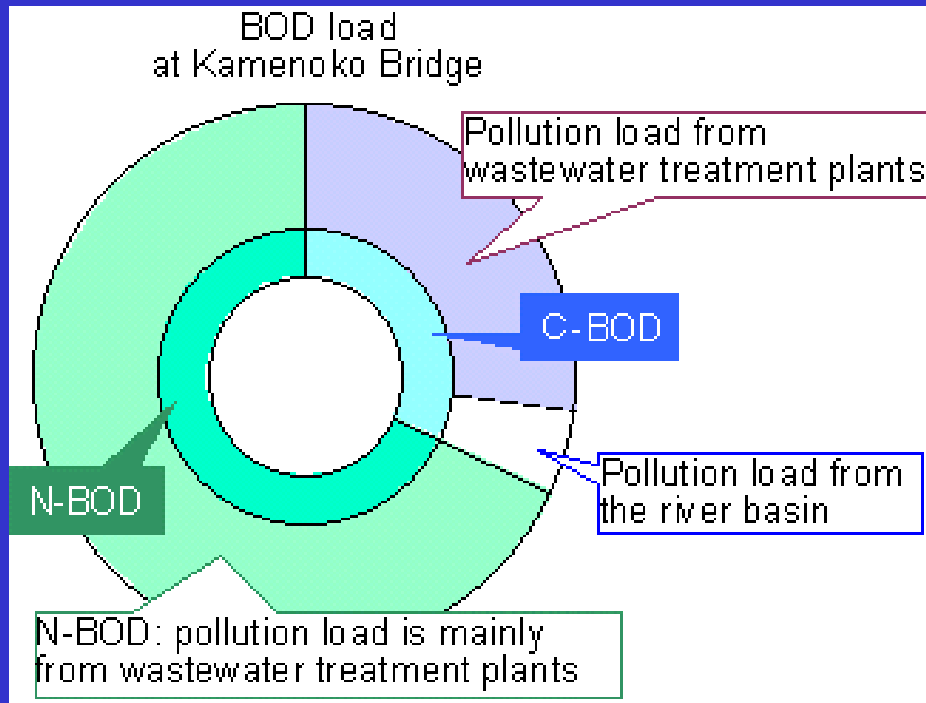
## ➤ Issues in water quality improvement

N BOD Measure

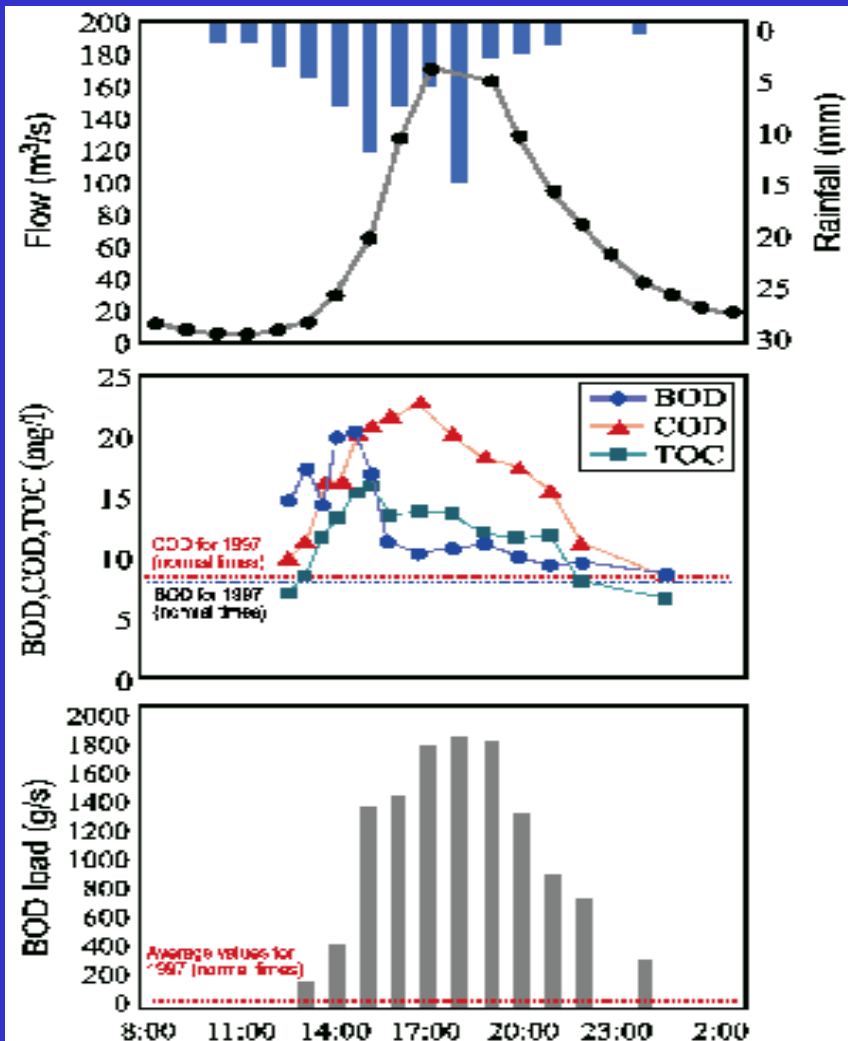
## Water quality measure for the rainy day

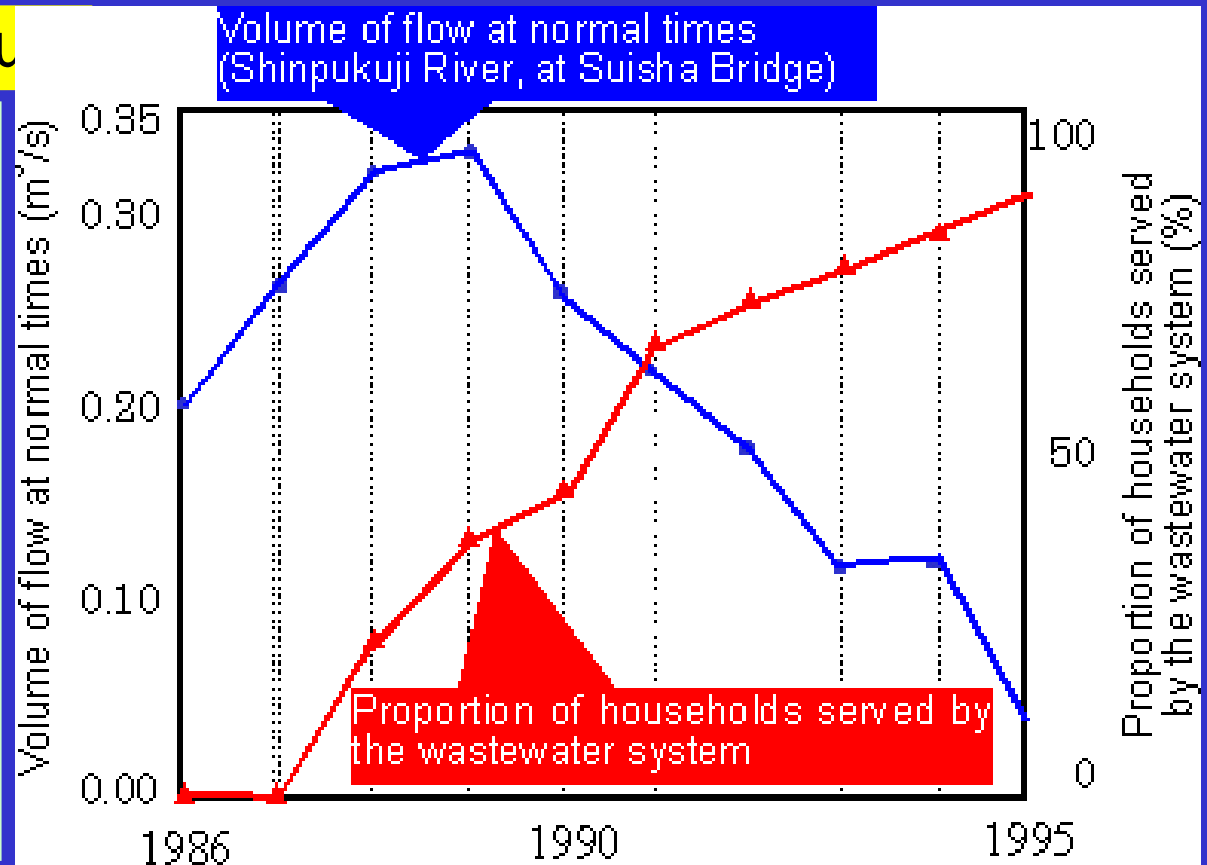
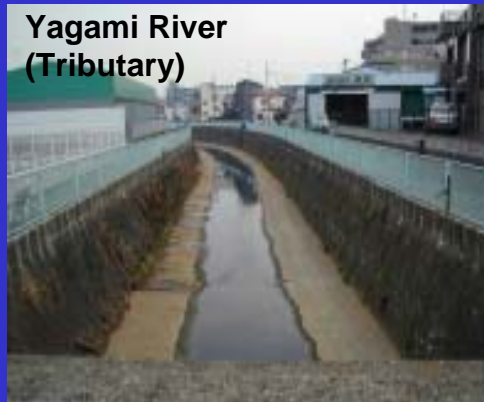
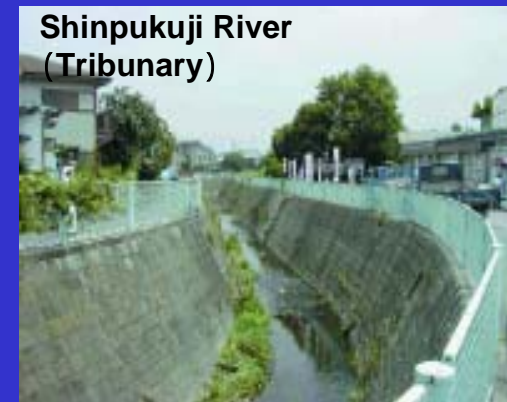
- Bypass by the Sewage System Improvement
  - concrete block revetment (Shutoff of groundwater inflow)
- Decreased water volume in upper reach

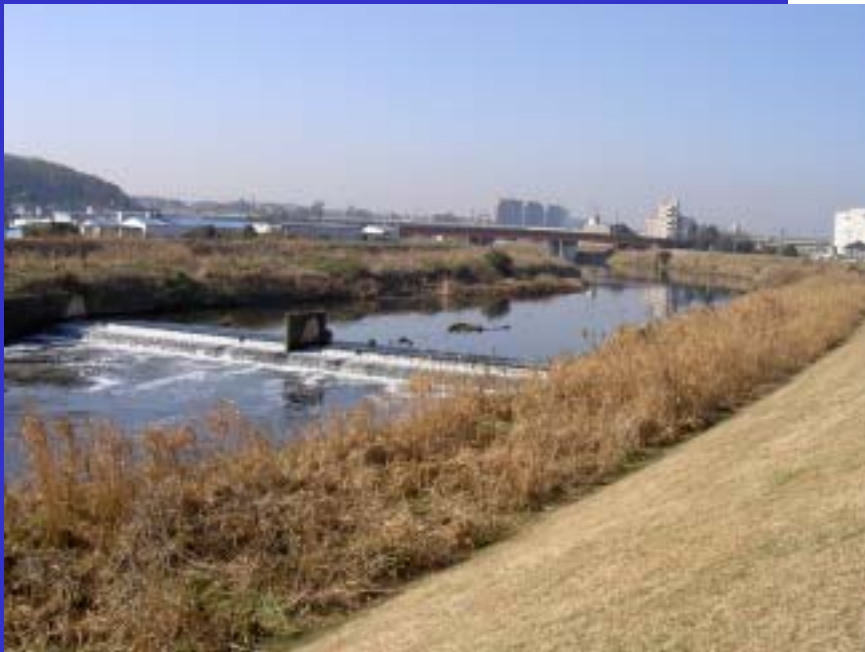
Abundant water volume in the downstream due to sewer discharge

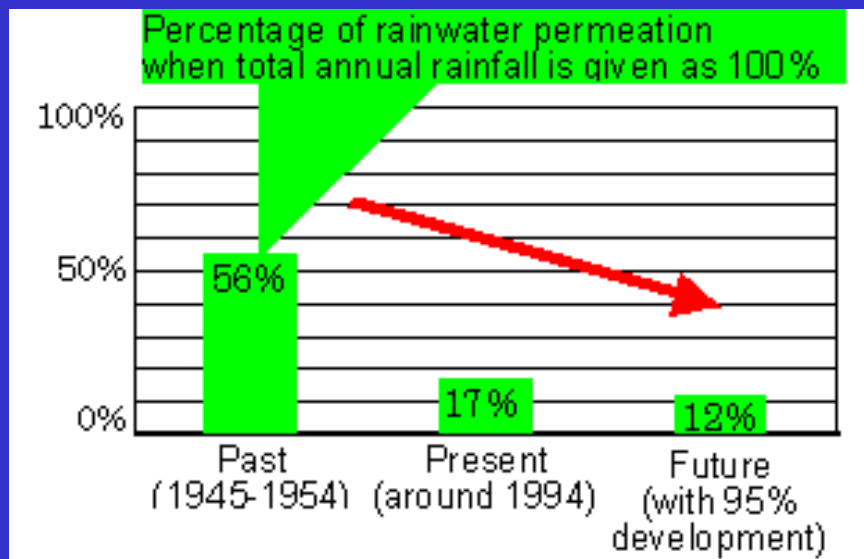
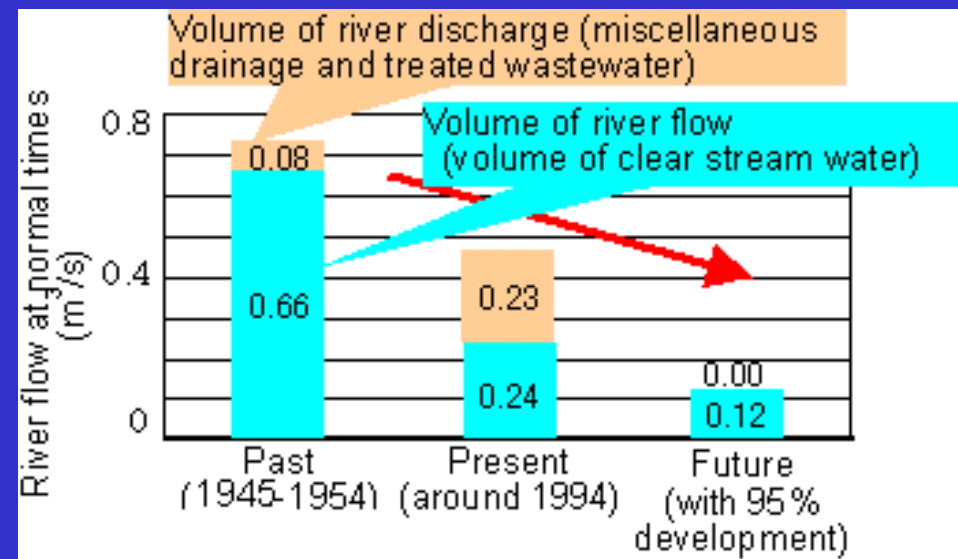
➤ Decreased rainfall infiltration

➤ Decreased river discharge  
➤ Decreased clean water

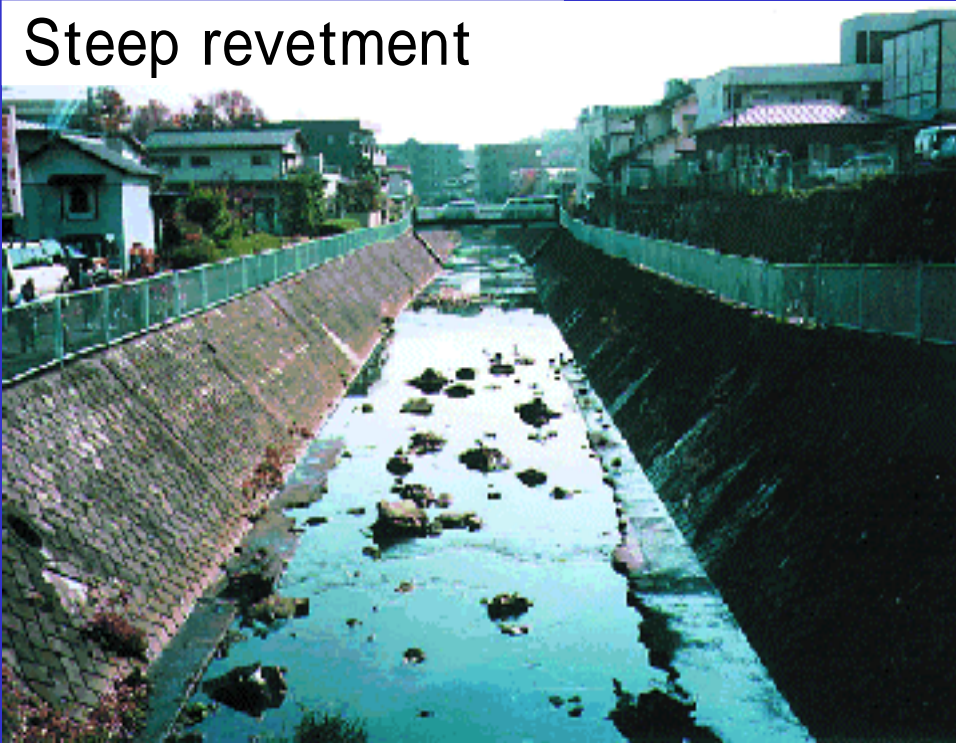
Steep revetment

- Issue in river improvement emphasizing flood control

- Difficult access to the water
- Unsuitable for inhabitation and growth of creatures
