# “Jyoryu Sabo Dam No. 10 ” Effective for trapping debris floods

## ■ Prevention of damage from a second disaster

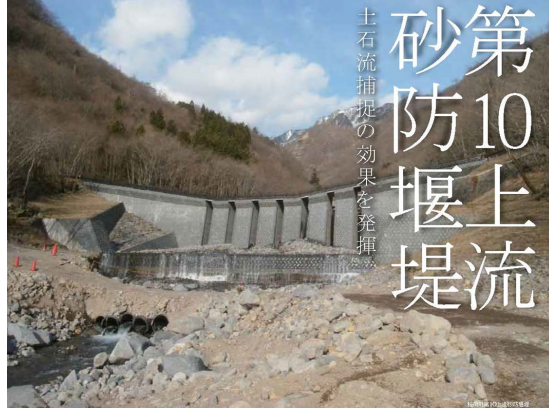
Before the debris flood occurred  
Debris deposit line caused by Typhoon No. 18 in 2015

One of the sabo dams constructed with the aim of controlling debris floods from the Inari River, located upstream of the Sabo Dam No. 10, a Registered Tangible Cultural Property and a Civil Engineering Heritage Site. It trapped debris floods and driftwood during Typhoon No. 12 in August-September 2011 and Typhoon No. 18 in September 2015, and protected the downstream area against damage.

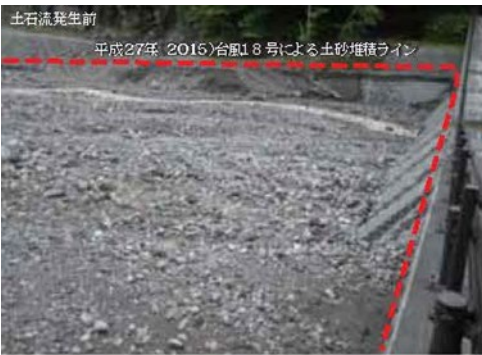
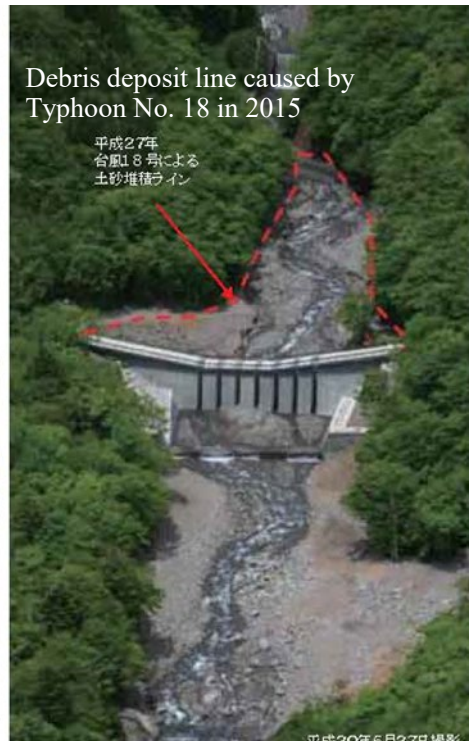
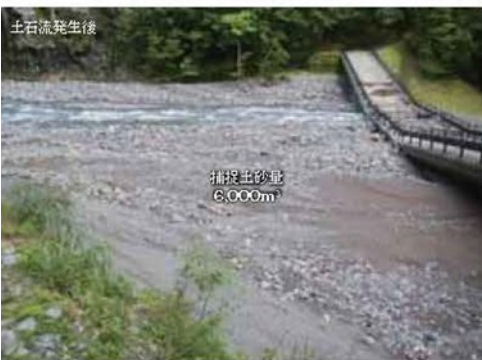
After the debris flood occurred
