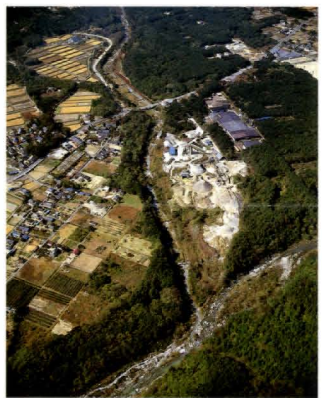
⑤ 濁川流路工 Nigorigawa channel work  
昭和43年頃、省力化を図るため、現場監督がビデオカメラを使い、工事。  
Around 1968, the video camera was used for cost reduction to direct the construction.

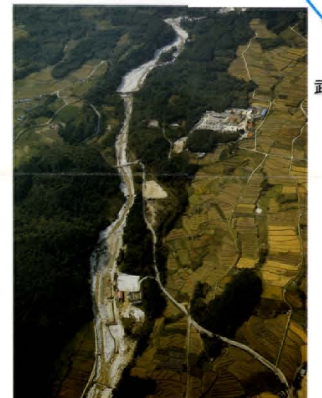
⑥ 尾白川下流砂防えん堤 Ojiragawa Karyu Sabo dam  
昭和35年に完成したえん堤に補強、耐震対策を行い、かつ観水水位が高まるよう修繕がなされた砂防えん堤。  
The reinforcing work for reinforcement and anti-earthquake feature was performed to the dam completed in 1963. A good accessibility to the river was also concerned during renovation of the sabo dam.

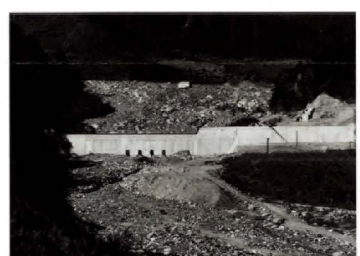
⑧ 篠沢第三砂防えん堤 Shirosawa No.3 Sabo dam  
白州出張所管内でも最も高い大規模砂防えん堤。  
This is the large size sabo dam with most vertical height in the Hakushi branch office area.

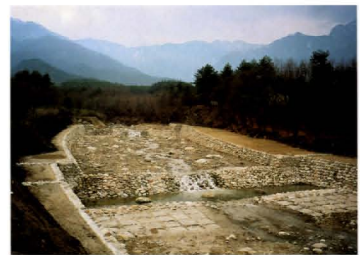
⑩ 大妻川床固群 Ohmukawa groundfills  
各種魚道、フレンドパークむかわ、龍弦など自然環境を活かし、地域づくりと一体となり整備。  
Concerning the natural environment, the various fishways, the Friend Park Mukawa, and Fugen were constructed harmonizing with the local development plan.

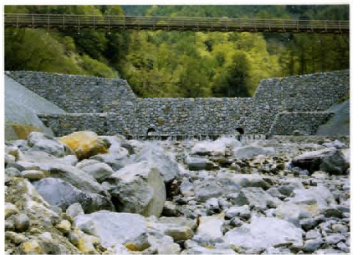
⑪ 大妻川床固群(石室川) Ohmukawa groundfills(Ishitorogawa)  
上流には風光明媚な精進ヶ滝があり、河岸にはカワセミも棲む豊かな周辺の環境と調和した施設づくり。  
There is a good sightseeing area. Shojigataki waterfall, at the upstream. The facility was constructed with a good balance among the nature where kingfishers reside near the banks.

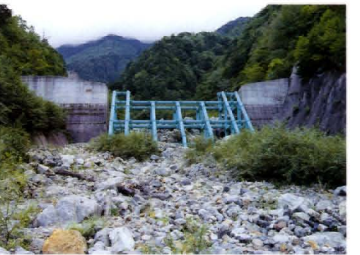
⑫ 石室川第六砂防えん堤 Ishitorogawa No.6 Sabo dam  
構造物表面に河床の巨石を積み、景観に配慮した砂防えん堤。  
This sabo dam has actual river stones on the structure surface for environmental concerns.

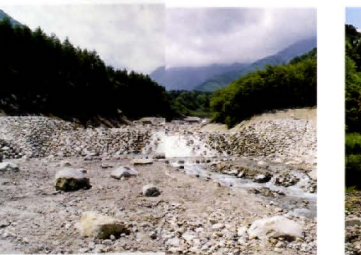
⑬ 大妻川第二砂防えん堤 Ohtanasawa No.2 Sabo dam  
関東地方整備局初の鋼製格子砂防えん堤。  
This is the first steel-pipe gridded sabo dam in the Kanto Regional Development Bureau.
