“Mt. Nantai”

■ Onagi Sanpukuko (major hillside decking works)

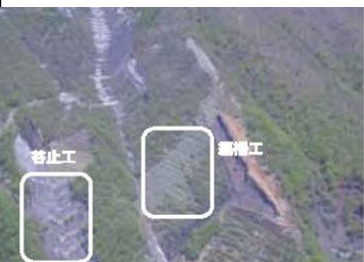
Wicket work, check dam work

To prevent this, Onagi Sanpukuko (major hillside decking work) is conducted. "Nagi" refers to collapsing marsh terrain formed from crumbling ridge areas, summits, etc.

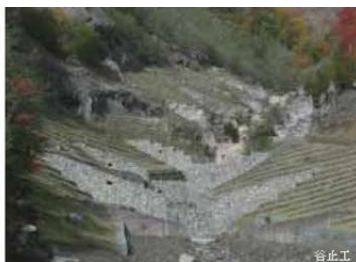
Check dam work

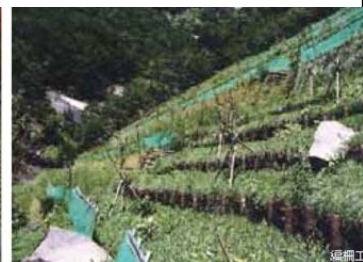
Wicket work
