“Houtou no Taki, Hannya no Taki Falls”

■ Sabo dams that melt into the scenery

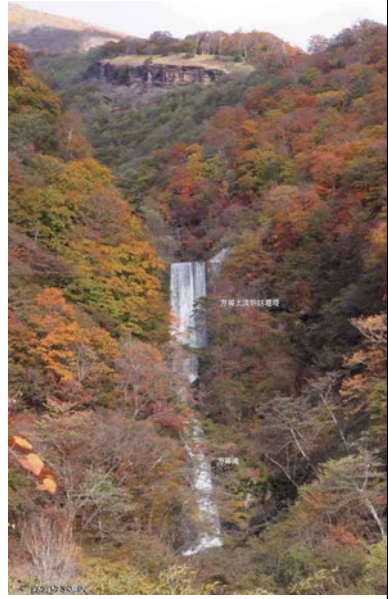
These two waterfalls can be seen from Kengamine. They both look like nothing but regular waterfalls, but this is actually the result of a reinforcement measure for which care was taken not to harm the scenery.

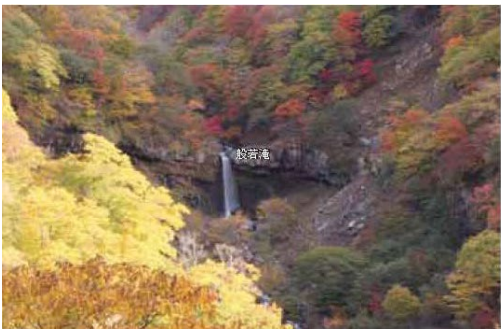
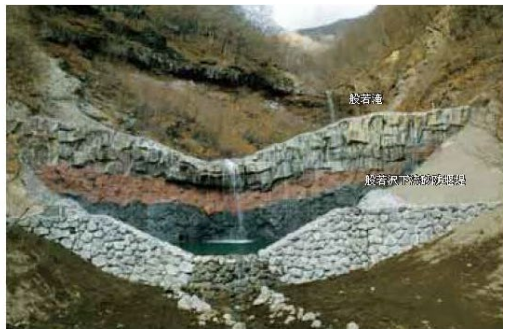
The Houtou Joryu Sabo Dam is a sabo dam made with coarse stone concrete completed in 1952. Because it was designated as a Registered Tangible Cultural Property for contributing to national historic scenery in 2003, when reinforcement work was necessary due to deterioration, measures were taken to not harm its appearance.

For Hannyazawa Karyu Sabo Dam, a mold was made of the existing rock, an "artificial form" was created, and concrete was poured in. After this, the surface was colored. This cleverly makes it melt into the scenery.
